UFZ Discussion Papers

Sequential Disaster Forensics: An Application to Floods in the City of Grimma

Marina Mendoza, Reimund Schwarze

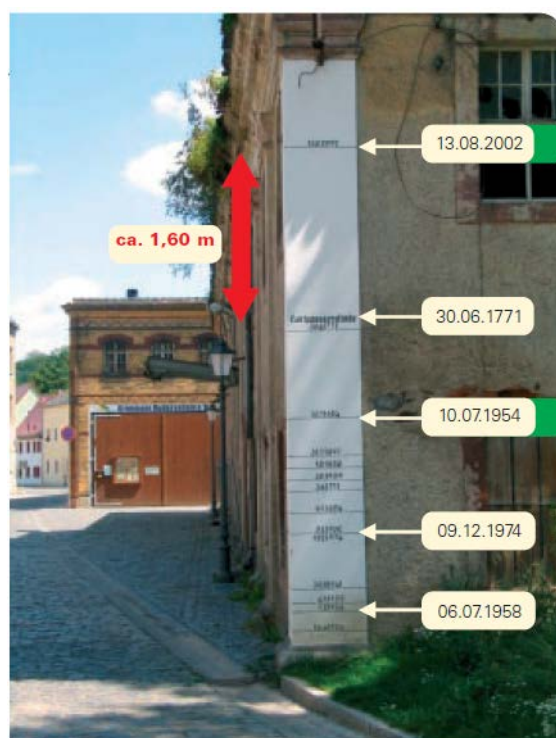
Historical records show that heavy floods occurred in Grimma in the years 1573 and 1771, while minor floods were expected every 20 years (Siedschlag, 2010). The last major flood before 2002 happened in Grimma in 1954, but the water level was not comparable either to the 2002 nor the 2013 floods (Figure 14 and Figure 15).

Figure 14 Water level of historic floods, on the Großmühle building in Grimma centre (Landestalsperrenverwaltung des Freistaates Sachsen, 2006).
