**11th Magdeburg Seminar on Waters in Central and Eastern Europe:
Assessment, Protection, Management**

Pollution of Elbe River flood plains and consequences for future research

The presented investigations are part of a research cluster which is focused to the evaluation of damages caused by the extreme flood event of the Elbe river in August 2002, sponsored by the BMBF.

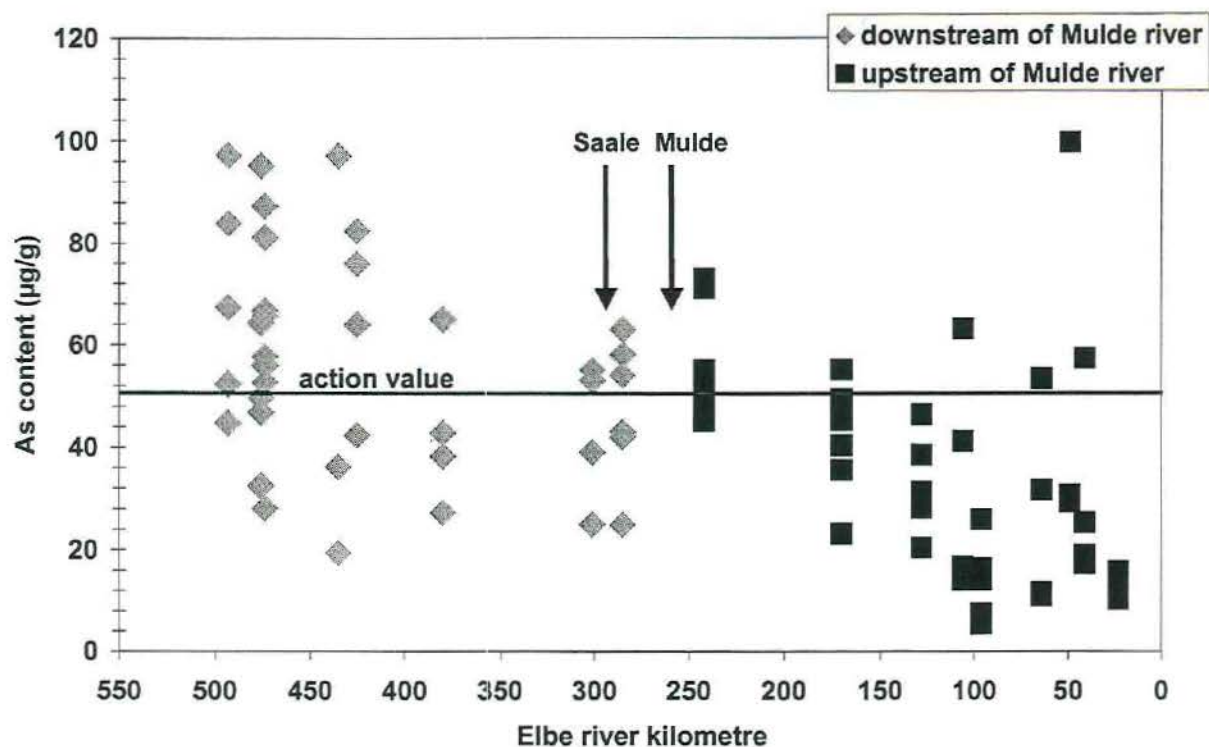
Figure 1: Arsenic contamination of Elbe river flood plain topsoils in comparison to the action value of the Federals Soil Protection and Contaminated Site Ordinance (BBodSchV).

The results confirm, that large parts of flood plains are highly contaminated with heavy metals and organic contaminants and they are enriched with pathogens. The measurements of contaminants in high flood sediments and topsoils show, that in general the flood event in August 2002 did not change the status of topsoil pollution. The exceedance of topsoil action values of the Federal Soil Protection and Contaminated Site Ordinance is common along the whole river Elbe (Figure 1) and the exceedance of threshold values for fodder, according to European guideline 2002/32/EG, can not be excluded (Figure 2).

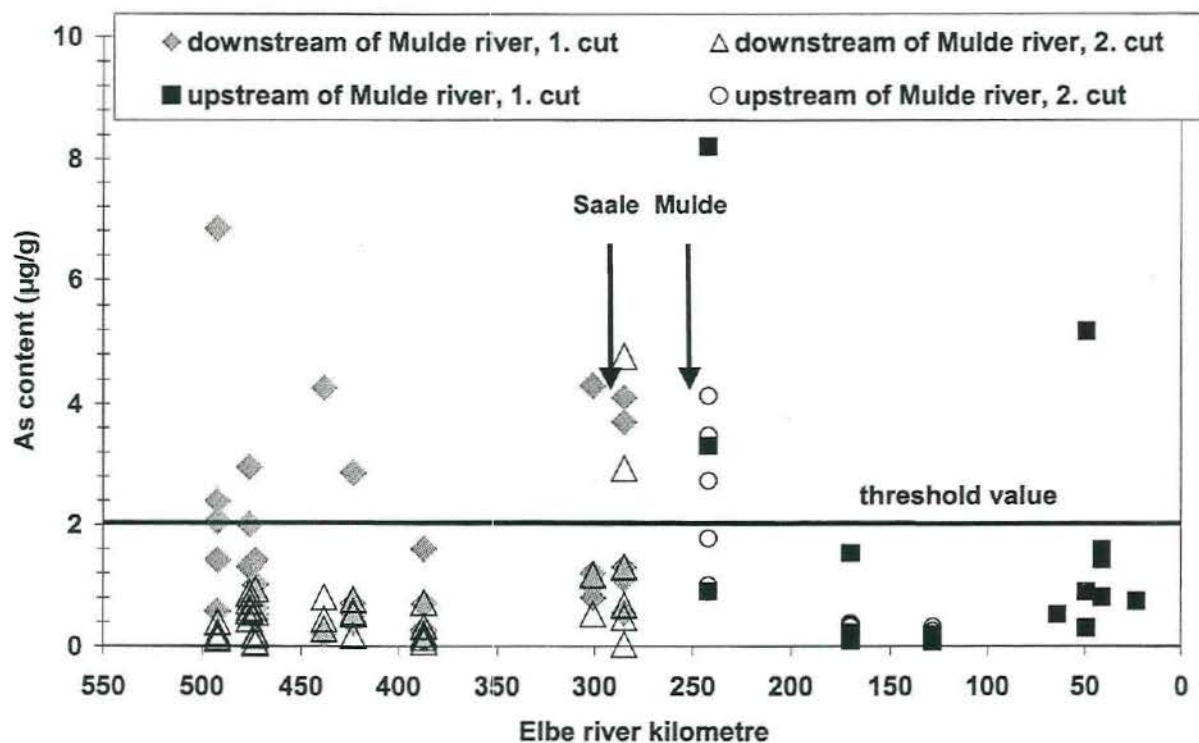
Figure 2: Arsenic contamination of grassland fodder in Elbe river flood plains at two harvesting times in 2003 in comparison to the threshold value of the European guideline 2002/32/EG.
